Case study: LeakPoint®/A10

Identifying failed gas lift valve eliminates wasteful mass replacement

Region: North Sea, UK
Well type: Gas lift oil producer

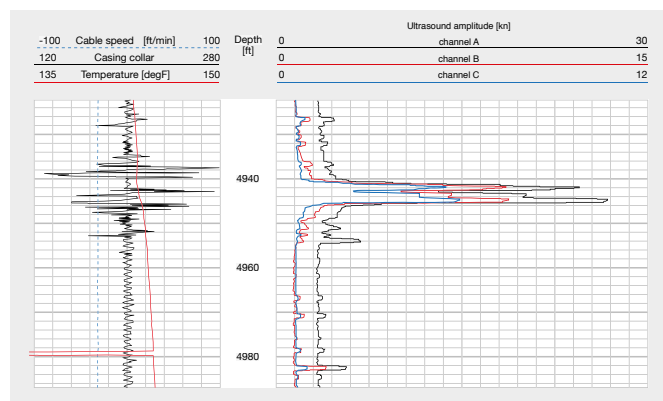
Leak at gas lift valve. The temperature log responds slightly at the leak point but lacks clarity and precision.

Two primary barrier leaks, one unexpected, were located after a single intervention with the LeakPoint/A10 logging platform. One leak was related to a GLV, the other identified within a tubing connection some 2,300 ft above the gas lift system. This information was presented to the operator at the well site and the decision was made to replace the leaking GLV before setting a straddle across the leaking tubing connection.

The GLV was successfully replaced, verified by a second run with the LeakPoint/A10 logging platform and a straddle set across the leaking connection. The additional verification run was essential as the restricted internal diameter of the straddle would have prevented access to the gas lift system after setting. Finally, following the remedial work, well integrity was confirmed and verified at surface before returning the well back to full production.

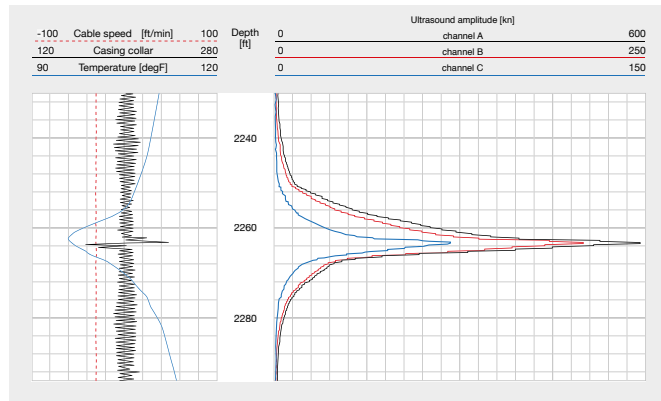
The diagnostic programme located a second unexpected leak at a tubing joint 2,300 ft above the gas lift system. This enabled the operator to complete the remediation program in a single campaign, saving time and resources.
