Case study: LeakPoint®/A10

Comprehensive diagnosis locates multiple unexpected leaks, enabling efficient remediation campaign

Region: Middle East, UAE
Customer: Dubai Petroleum
Field: Fateh
Well type: Gas lift oil producer
Reference: SPE-117182-PP

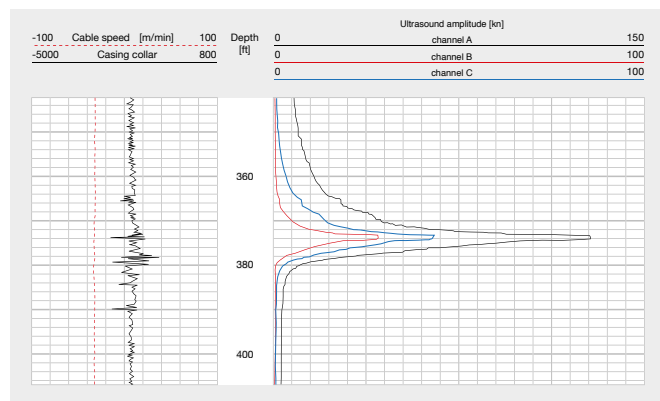
Clearly identified primary barrier leak at ball valve.

The damaged GLV dummy was confirmed leaking and, significantly, three further leaks were located: in a control line, a big-bore ball valve and a second GLV dummy.

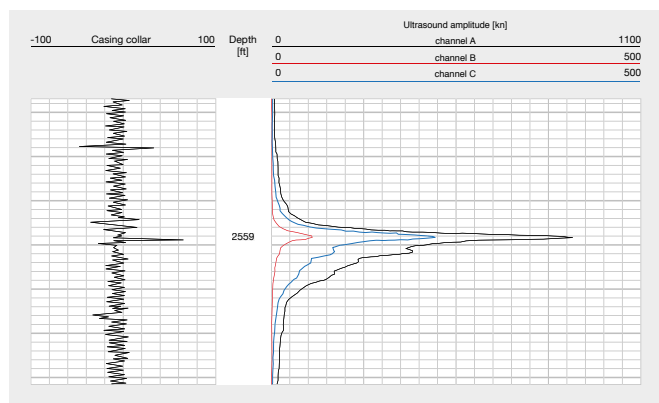
Leak at second dummy gas lift valve.

The mandrels containing the failed GLV dummies were both sealed using straddle patches.
