Case study: LeakPoint®/A30

Diagnostic programme locates extremely low-rate casing leak, enabling effective remediation

Region: Middle East, Qatar
Customer: Qatar Petroleum
Field: Dukhan
Well type: Onshore gas producer
Reference: IPTC 11583-PP

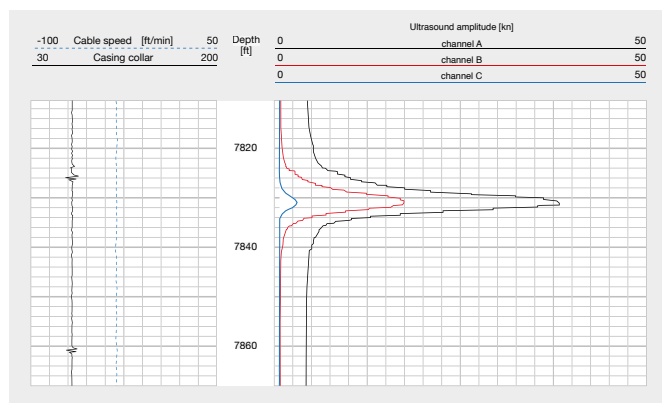
The leak depth is clearly identified on the field log. The symmetrical shape of the log response is an indication of a leak beyond the tubing. Correlating this response with surface observations and other well information enabled the analyst to locate the failed barriers — a DV stage cementing tool in the 7-in. casing and poor cement in the B-annulus.

At 7,830 ft a clear leak signature appeared on the log and this was subsequently confirmed with station logging across the zone. The location of the leak correlated exactly with a stage cementing Diverter Valve [DV] tool in the 7-in. casing. The well history showed the DV had previously failed a pressure test and further investigations at surface confirmed that the leak was not in the tubing.

The LeakPoint programme accurately located a micro-leak at the DV tool. The LeakPoint analyst concluded that gas was leaking through the DV tool after channeling through a flowpath in the cement below the DV.

The well was scheduled for a workover. A cement evaluation log confirmed poor cement below the DV tool, validating the diagnosis. A secondary cement job was performed and a new completion deployed. This resolved the integrity failure and the annulus pressure problem, restoring the well to normal production.
