Case study: LeakPoint® /A10

Identifying failed gas lift valve eliminates wasteful mass replacement

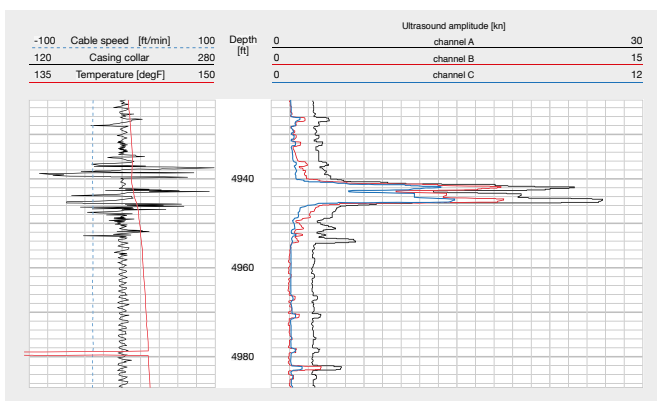
Leak at gas lift valve. The temperature log responds slightly at the leak point but lacks clarity and precision.

The GLV was successfully replaced, verified by a second run with the LeakPoint/A10 logging platform and a straddle set across the leaking connection. The additional verification run was essential as the restricted internal diameter of the straddle would have prevented access to the gas lift system after setting. Finally, following the remedial work, well integrity was confirmed and verified at surface before returning the well back to full production.

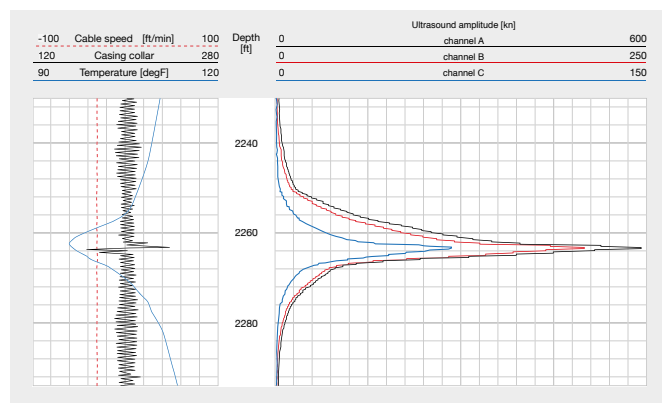
The diagnostic programme located a second unexpected leak at a tubing joint 2,300 ft above the gas lift system. This enabled the operator to complete the remediation program in a single campaign, saving time and resources.
