Case study: LeakPoint®/A10

Identifying failed gas lift valve eliminates wasteful mass replacement

Region: North Sea, UK
Well type: Gas lift oil producer

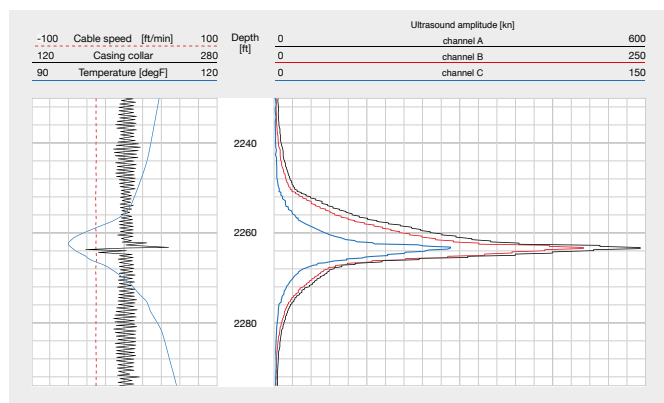
The diagnostic programme located a second unexpected leak at a tubing joint 2,300 ft above the gas lift system. This enabled the operator to complete the remediation program in a single campaign, saving time and resources.

The GLV was successfully replaced, verified by a second run with the LeakPoint/A10 logging platform and a straddle set across the leaking connection. The additional verification run was essential as the restricted internal diameter of the straddle would have prevented access to the gas lift system after setting. Finally, following the remedial work, well integrity was confirmed and verified at surface before returning the well back to full production.
