## Case study: LeakPoint®/A10

# Locating barrier leak rapidly and accurately in new complex completion delivers substantial operator savings

**Region:** North Sea, Norway  
**Well type:** Newly-completed producer

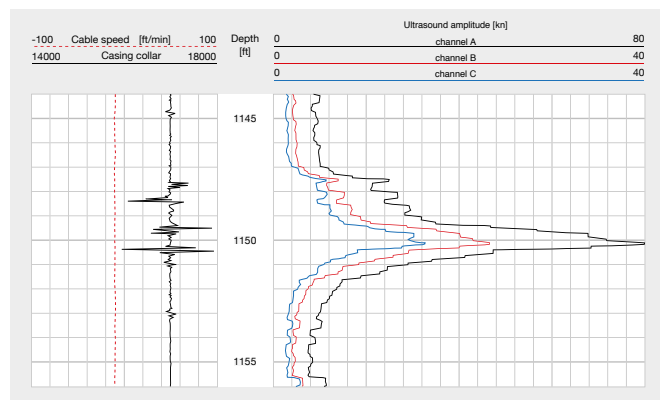
Leak clearly evident at GLV dummy. The peak reveals the exact location of the leak point.

A LeakPoint/A10 programme was selected and completed in under 10 hours. This precisely located a leak in the upper GLV dummy, which was retrieved and found to be damaged.

The failed GLV dummy was replaced, a pressure test was performed and no further leakage was found.

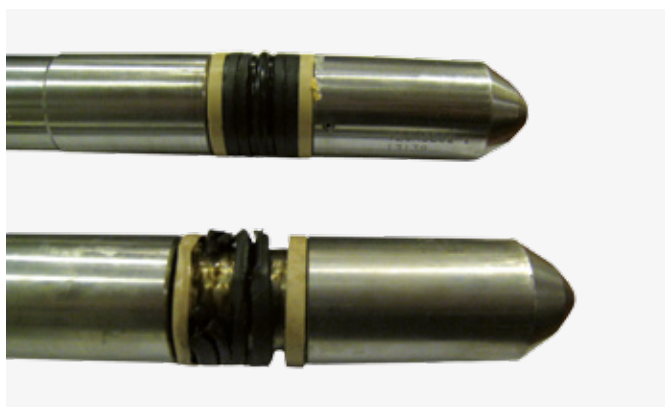
Retrieved GLV dummy (bottom) with its damaged seal. A healthy GLV replacement is shown (top).
