Innovative scale removal system enables safe and efficient restoration of TRSSSV integrity - A case study from the Nelson field

Safe and efficient restoration of TRSSSV integrity

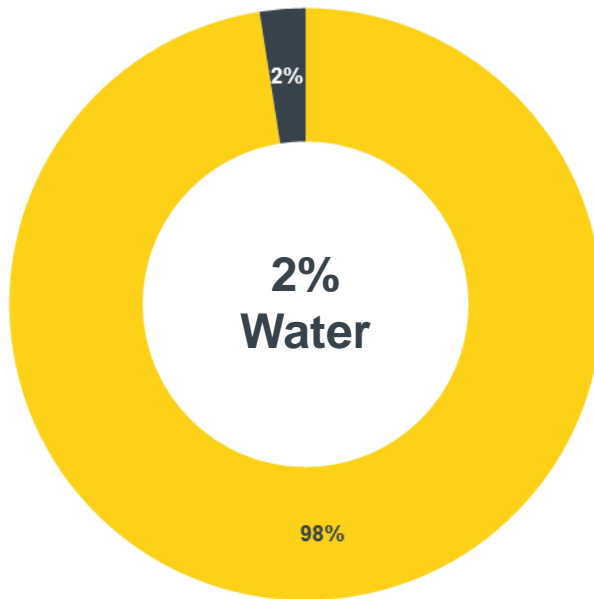
1994 Production

■ Oil Production ■ Water Production

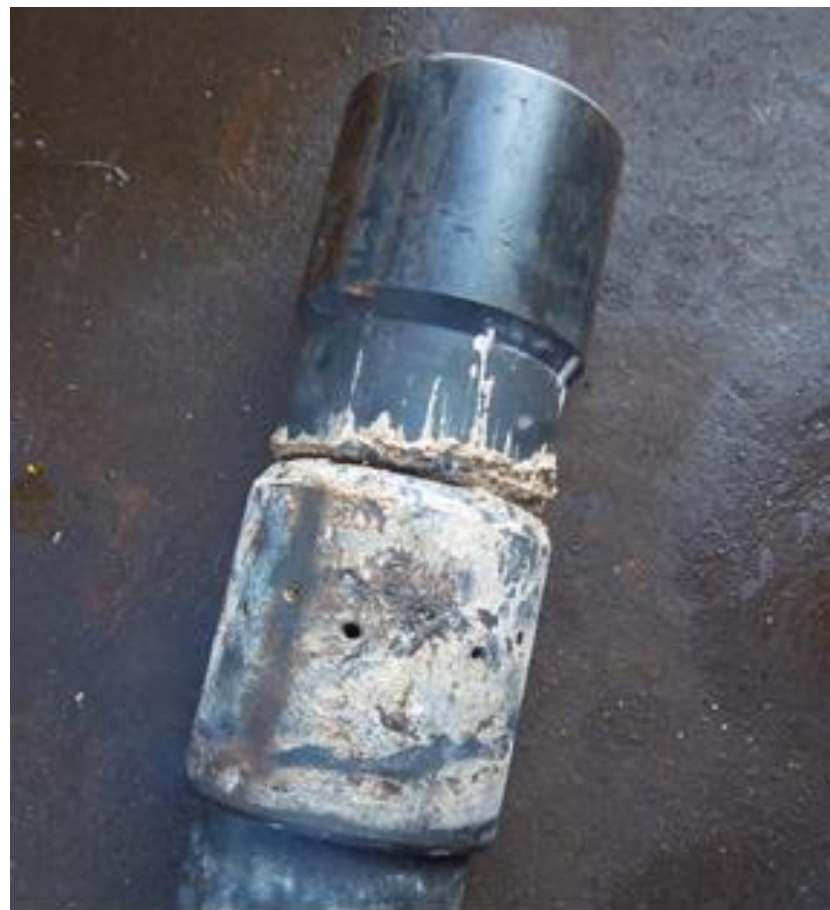
- A TRSSSV insert valve retrieved in 2011 showed carbonate deposition
- Production log surveys in 2011 encountered rings of carbonate scale in the well.

Scale at the top of lock

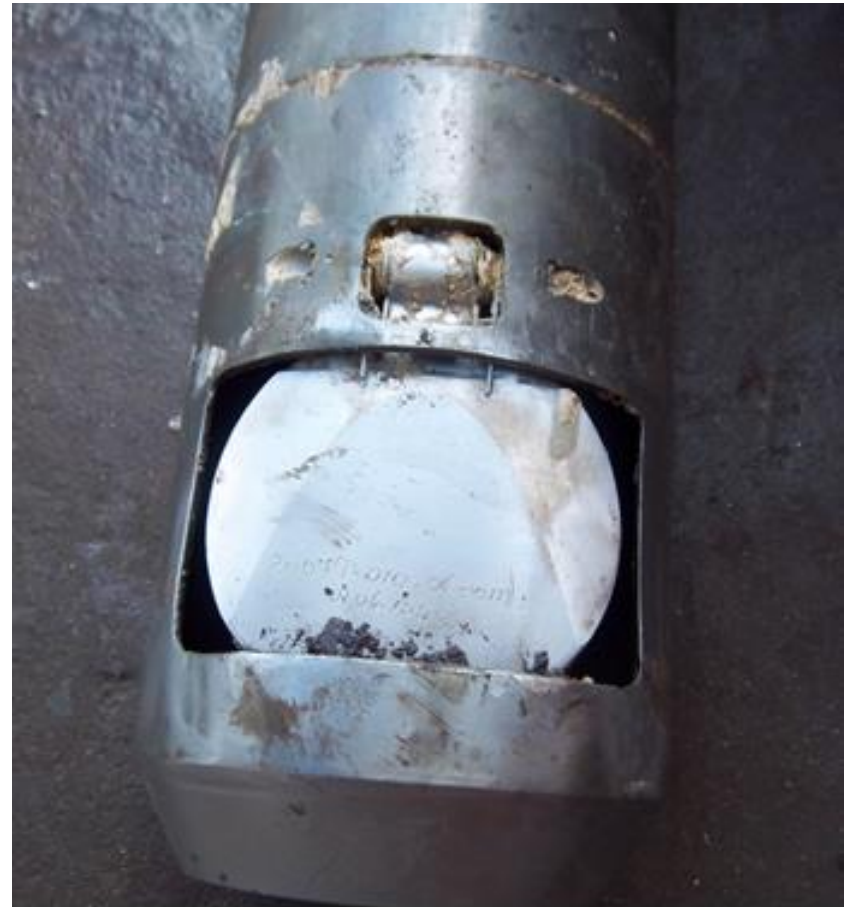
- A TRSSSV insert valve retrieved in 2011 showed carbonate deposition
- Production log surveys in 2011 encountered rings of carbonate scale in the well.

Flapper being held open by flotube

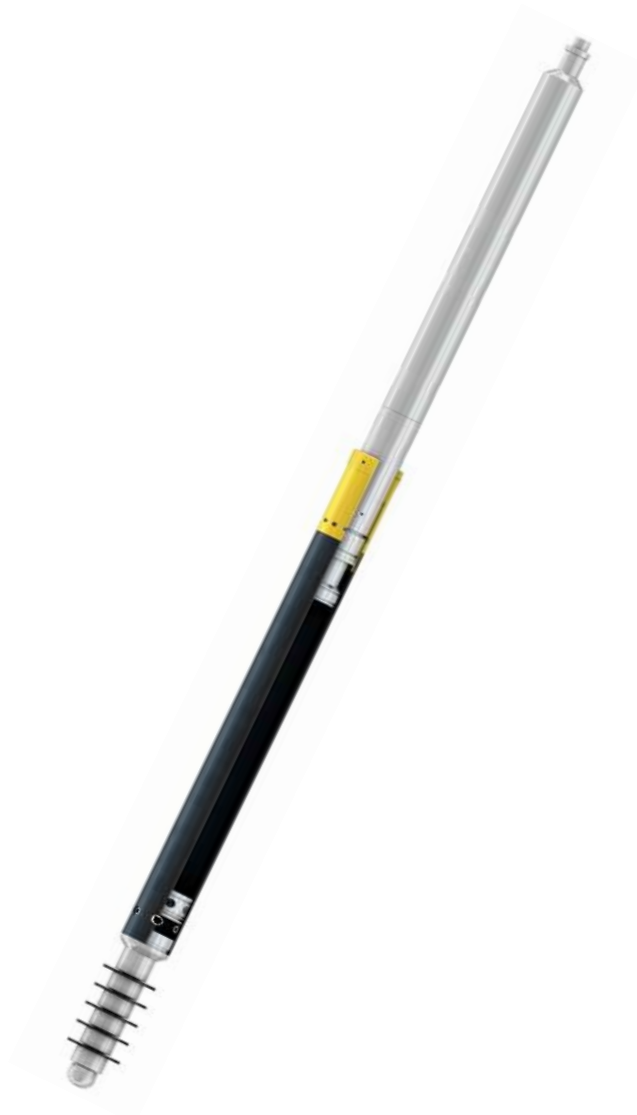
Archer TASK system selected as remedial technique

- Targeted chemical treatment of TRSSSV deployed with slickline
- Precision circulation system to wash affected area with zero abrasion risk
- Use of low hazard chemicals with closed-loop safe filling system.

- TASK/1: Optimized for Calcium, Barium and Strontium sulphate scale
- TASK/2: Optimized for Calcium Carbonate scale

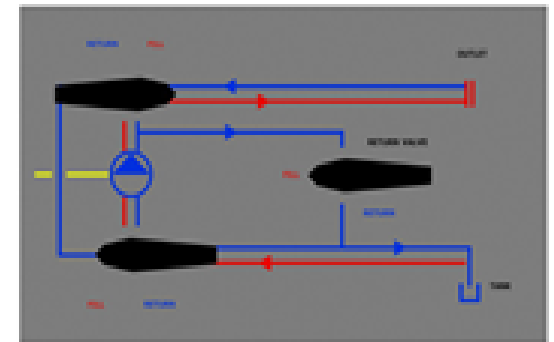
closed-loop safe filling system

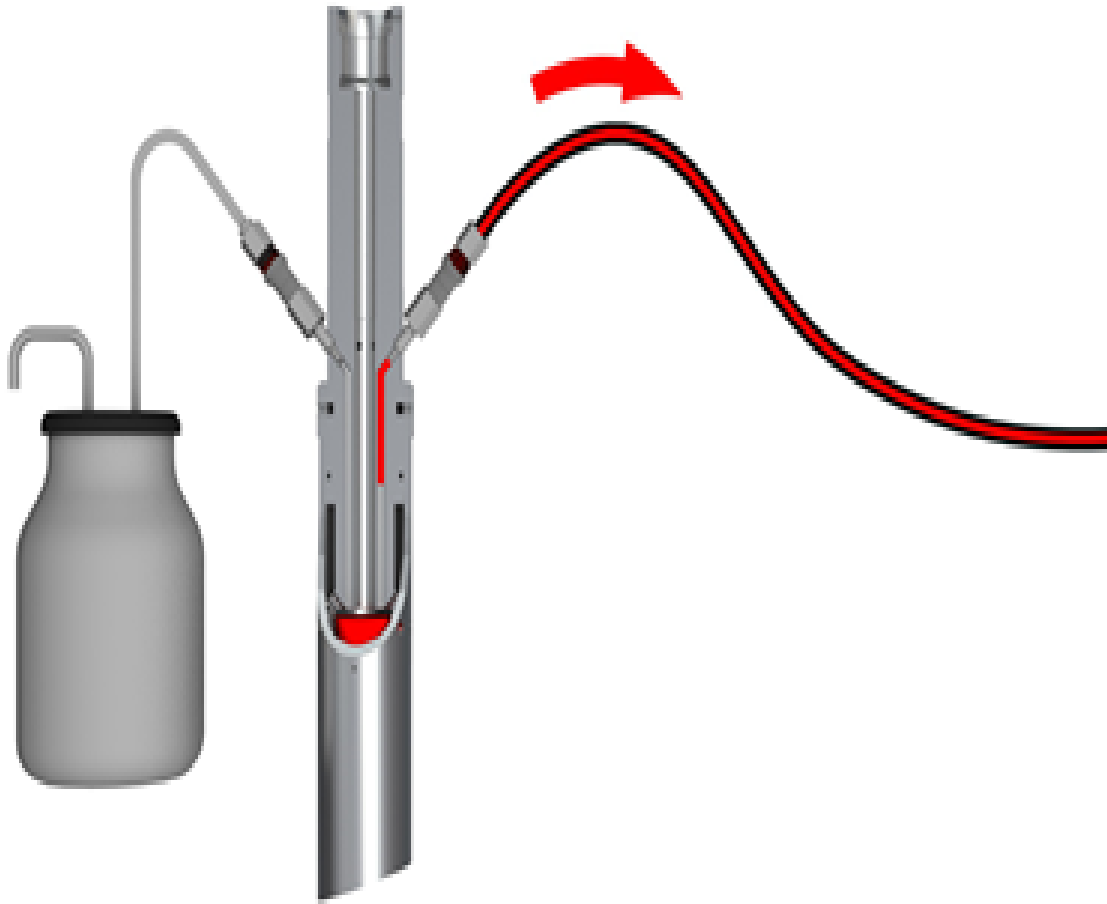
Reverse pumping chemical back to tank to avoid spill
