Case study: LeakPoint®/A10

Identifying failed gas lift valve eliminates wasteful mass replacement

Region: North Sea, UK
Well type: Gas lift oil producer

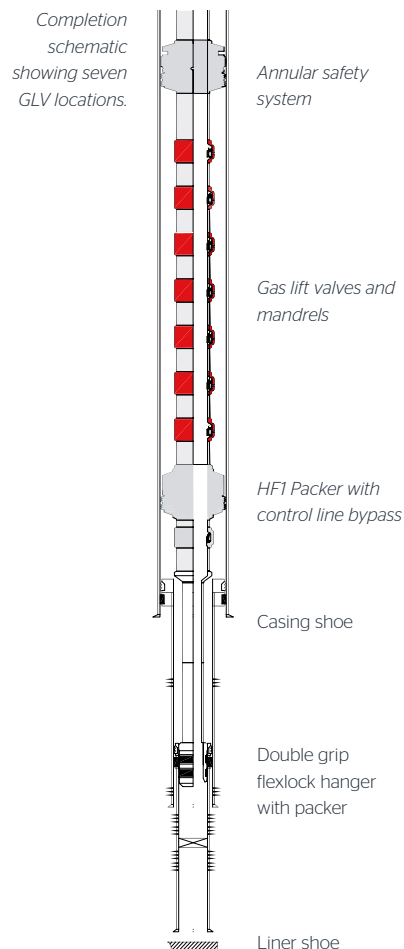
The diagnostic programme located a second unexpected leak at a tubing joint 2,300 ft above the gas lift system. This enabled the operator to complete the remediation program in a single campaign, saving time and resources.
