## **Case study:** Tornar Wellbore Cleaning Technology

# Archer Oiltools' successful wellbore cleaning job for an OMV well in the Barents Sea

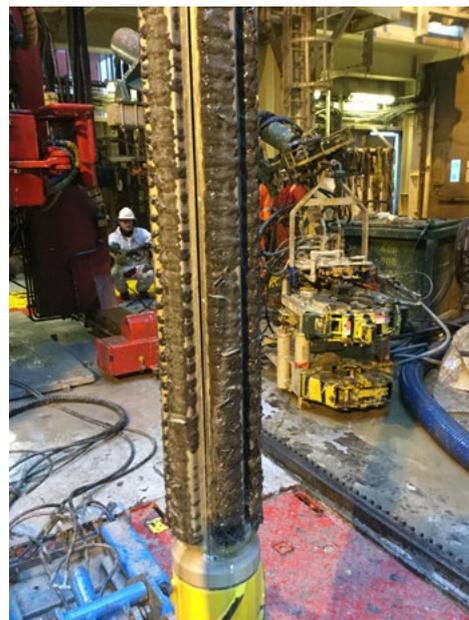
7" Tornar magnet with debris.

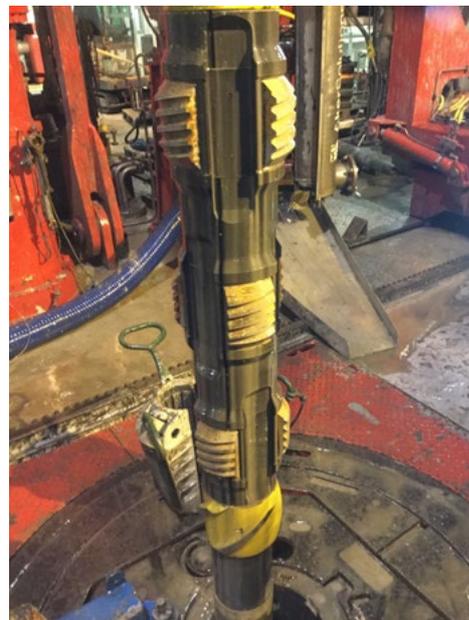
Tornar casing scraper.
